Request for Speed Limit Reduction

Parish: Coddenham County: Suffolk Post Code: IP6 9UB Grid Reference: TM1187554802

Road No.: B1078

Description: Portion of road passing through the hamlet of Lime Kilns (8 residential properties with frontage and access onto B1078)

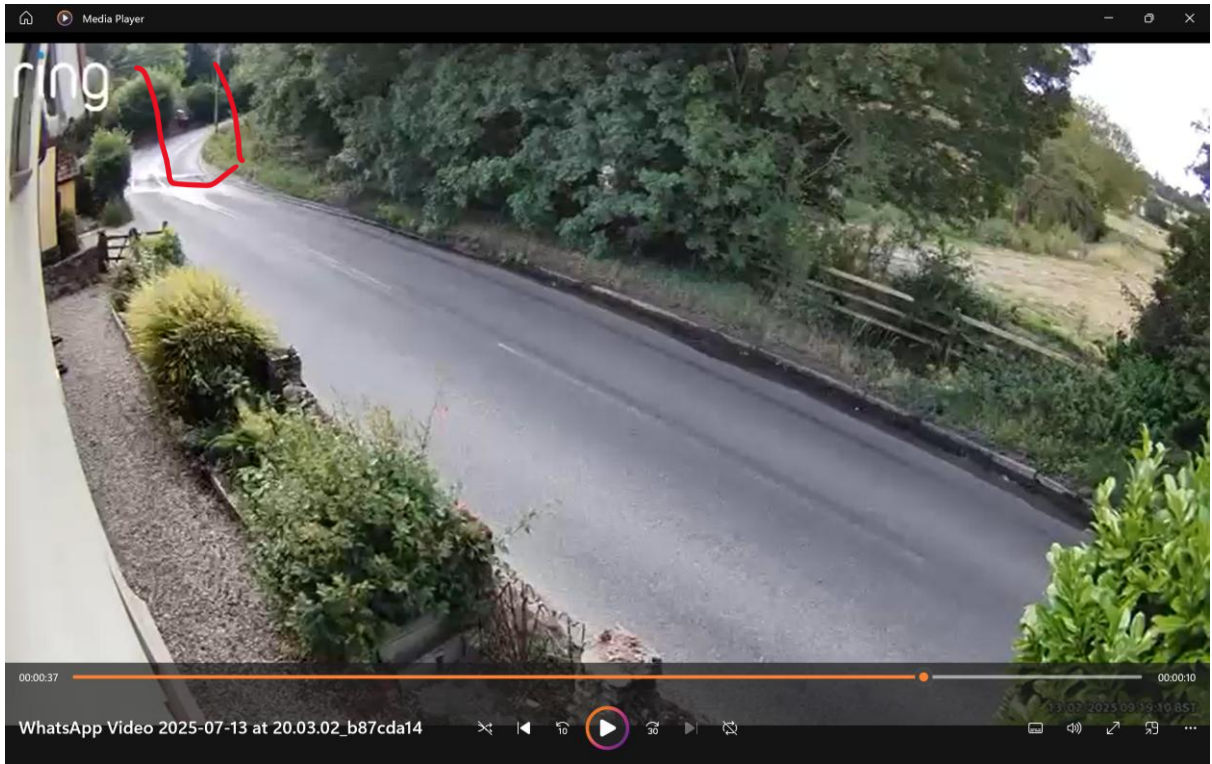
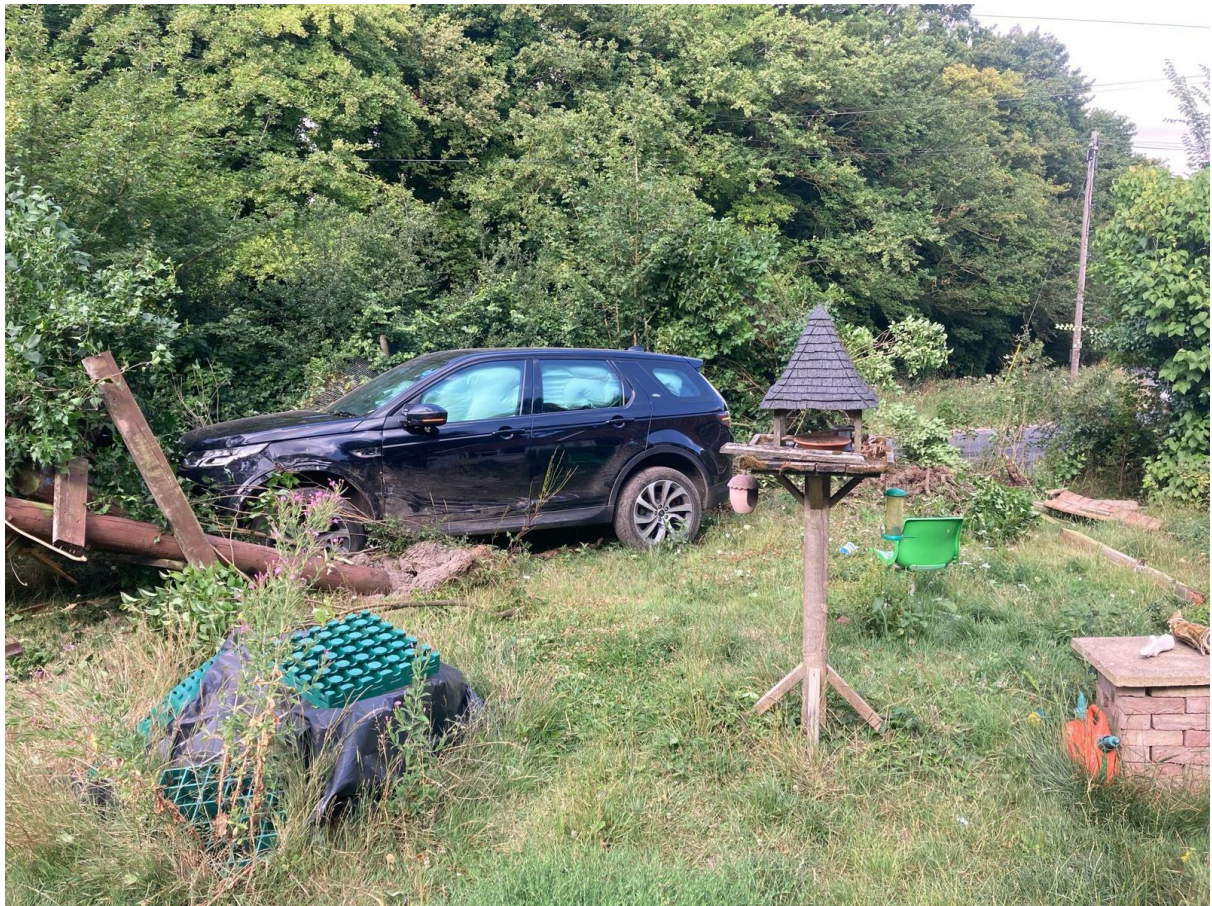
Road traffic accidents are frequent and probably not always reported. There are often signs of vehicle damage with broken wing mirrors and other vehicle parts littering the edge of the road. More serious accidents that residents have seen have included 4 vehicles bursting through the hedge into the garden of Lime Kiln Bungalow and 2 overturned vehicles that remained on the road. The picture below is a still from a video recording of the accident that occurred on 13/7/25 where the car ended up in the garden of Lime Kiln Bungalow and a picture of the car that left the road. This accident demolished the children's play equipment in the garden. It is fortunate no child was using it at the time.

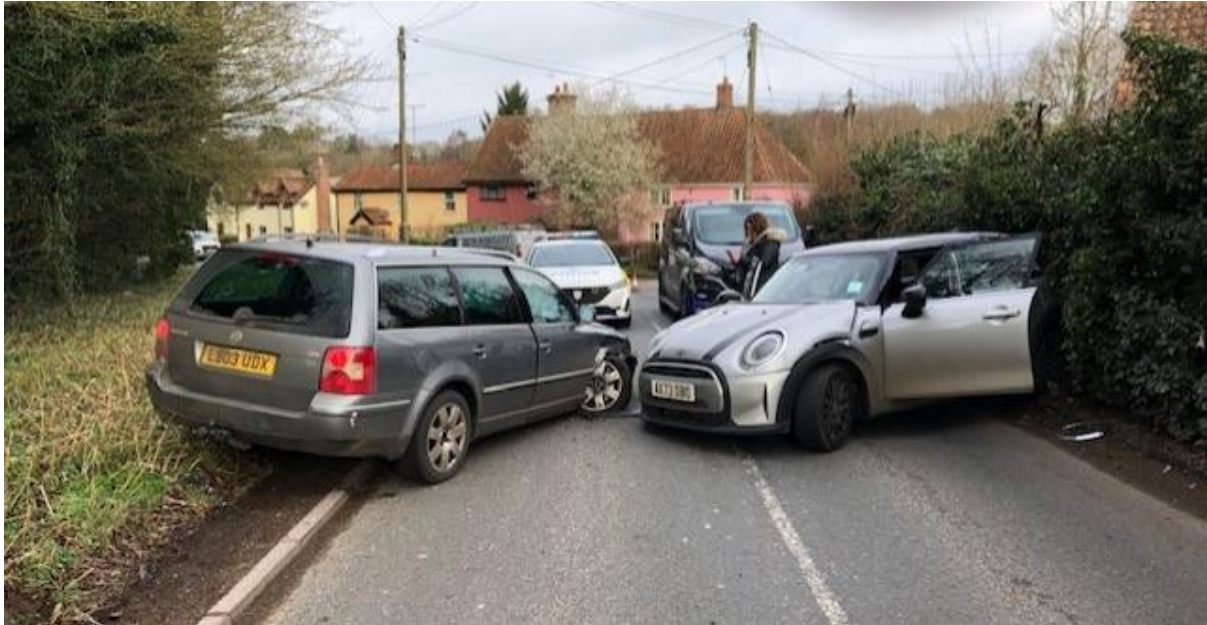
Below is a photo of the car belonging to Councillor David Penny, which was written off by a driver coming round the bend from the A140 direction on the wrong side of the road.

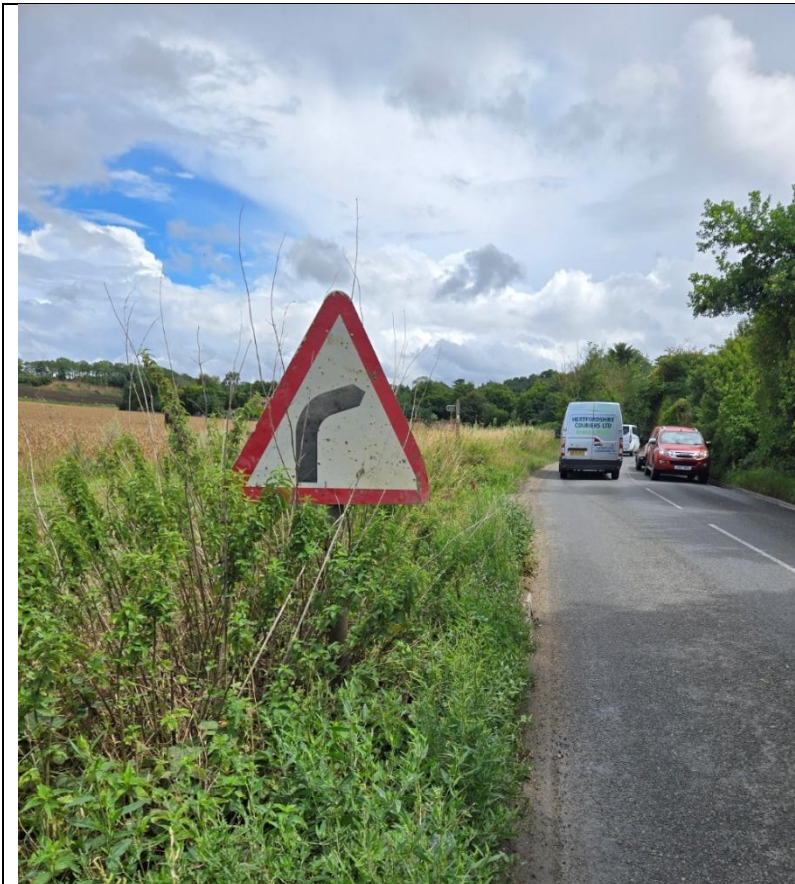
Eastbound bend warning sign (face pot marked and deteriorated).
The 'SLOW' road marking that used to accompany the sign was not replaced when the road was last surface dressed.

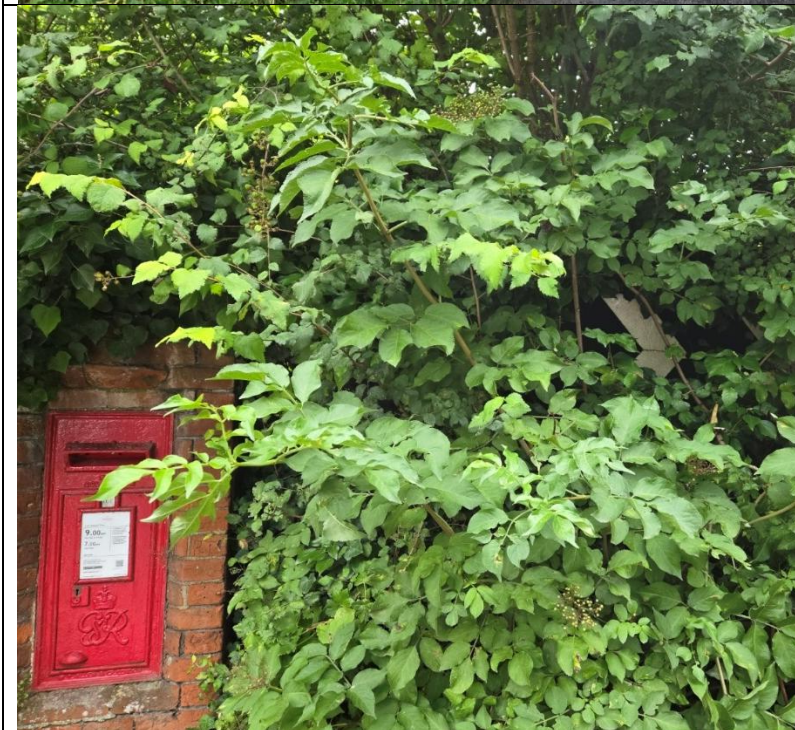
Eastbound Chevron sign at bend. Last visible in Google street view in May 2023

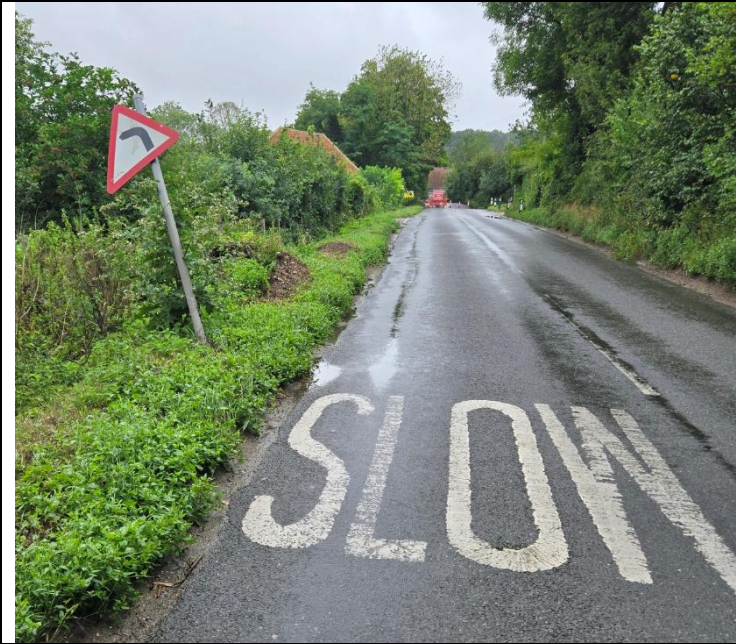
Westbound bend warning sign (face faded, post and mounting collapsing)

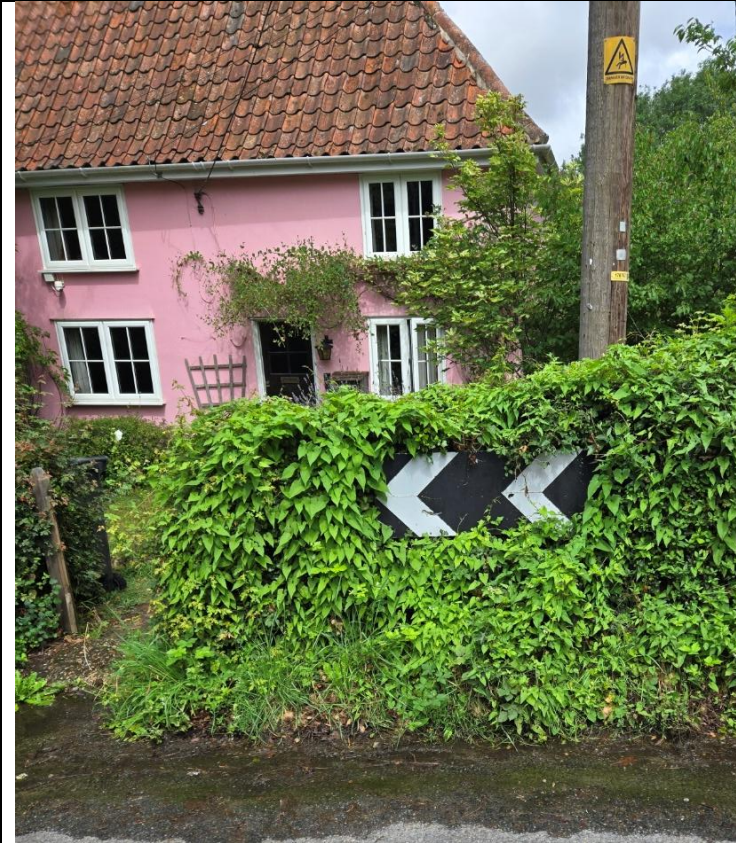
Westbound Chevron Sign at bend

The signage is generally in poor condition or obscured.
